## Flight control occurrence.

On 20 February 2014, Virgin Australia Regional Airlines was operating an ATR 72 aircraft, registered VH-FVR, on two scheduled passenger flights from Sydney, New South Wales (NSW) to Canberra, Australian Capital Territory and return. This was to be followed by a charter flight to Narrabri, NSW and return.

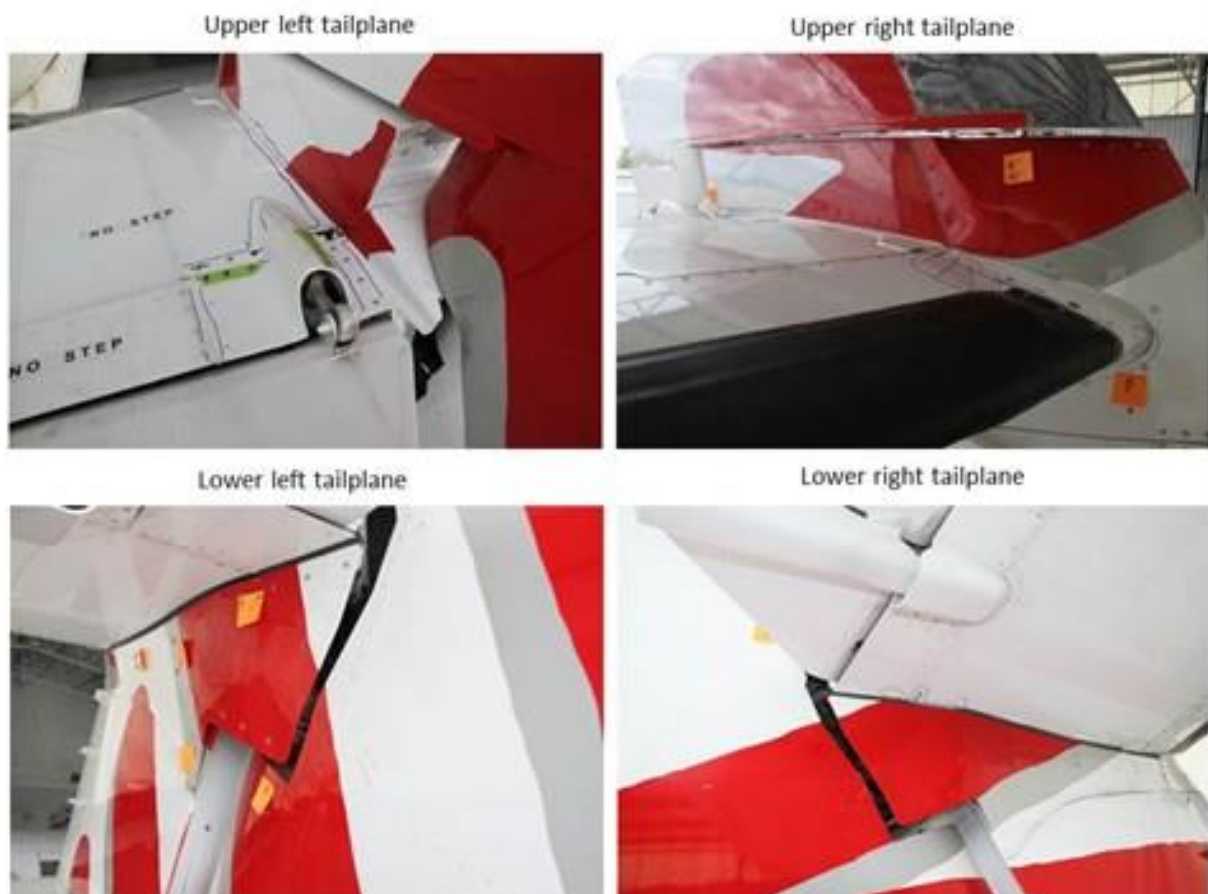
The engineer used scissor lift equipment to inspect the tailplane and confirmed that the fairing might have been damaged by a bird but that there was also significant structural damage on top of the tailplane. The aircraft was grounded and the ATSB advised.

The aircraft manufacturer inspected the aircraft and found broken carbon plies, cracked joint sealant, and deformation in and around the area where the horizontal stabiliser attaches to the vertical stabiliser (Figures 2 and 3). There was also some minor damage to the rudder. The damage was assessed as being consistent with an overstress condition. Subject to further assessment and non-destructive testing, the aircraft manufacturer recommended replacement of the horizontal stabiliser, elevators, and vertical stabiliser.

**Figure 2: Tailplane external damage** (indicated by marks and stickers)

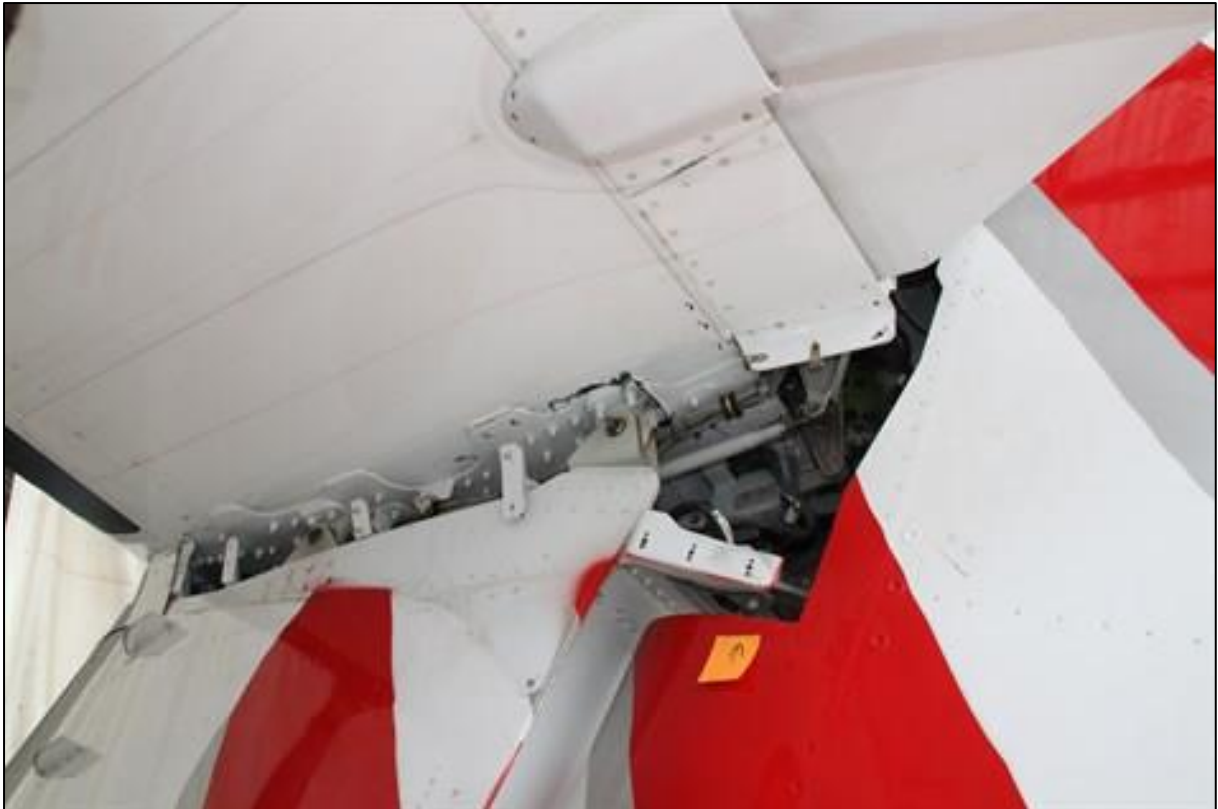
**Figure 3: Left tailplane attachments (fairing removed)**
