National Transportation Safety Board Aviation Accident Preliminary Report

Location:	Cooper Landing, AK	Accident Number:	ANC20FA007
Date & Time:	11/29/2019, 1911 AKS	Registration:	N4087G
Aircraft:	Piper PA-31-350	Injuries:	3 Fatal
Flight Conducted Under:	Part 135: Air Taxi & Commuter - Non-scheduled - Air Medical (Medical Emergency)

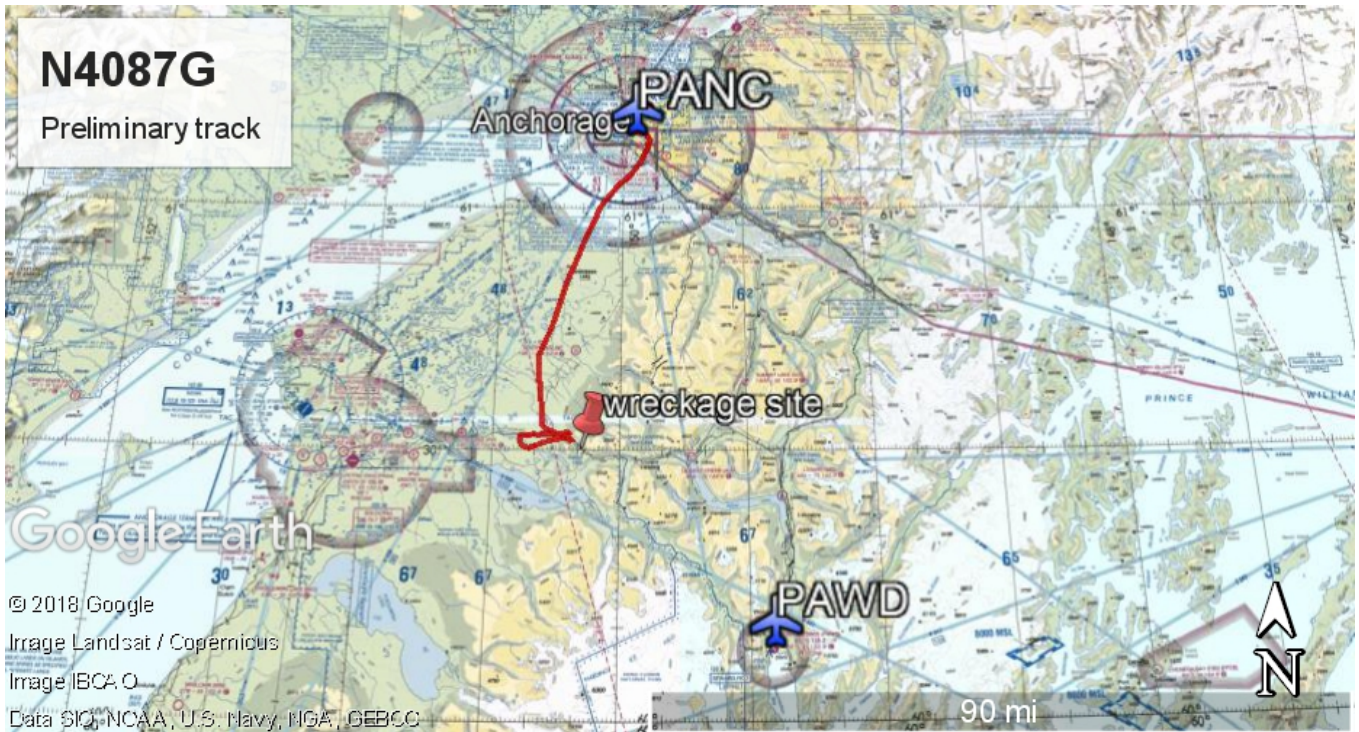
Figure 1. Preliminary flight track

A preliminary review of archived Federal Aviation Administration (FAA) radar and automatic dependent surveillance (ADS-B) data revealed that the accident airplane departed PANC and flew south about 3,000 ft mean sea level (msl) toward the Sterling Highway. The airplane was then observed descending to 2,200 ft msl while flying a right racetrack pattern before flying into the valley toward Cooper Landing. The last data point indicated that at 1911:14 the airplane was over the west end of Jean Lake at 2,100 ft msl, on a 127° course, and 122 kts groundspeed. Refer to figures 1 and 2.

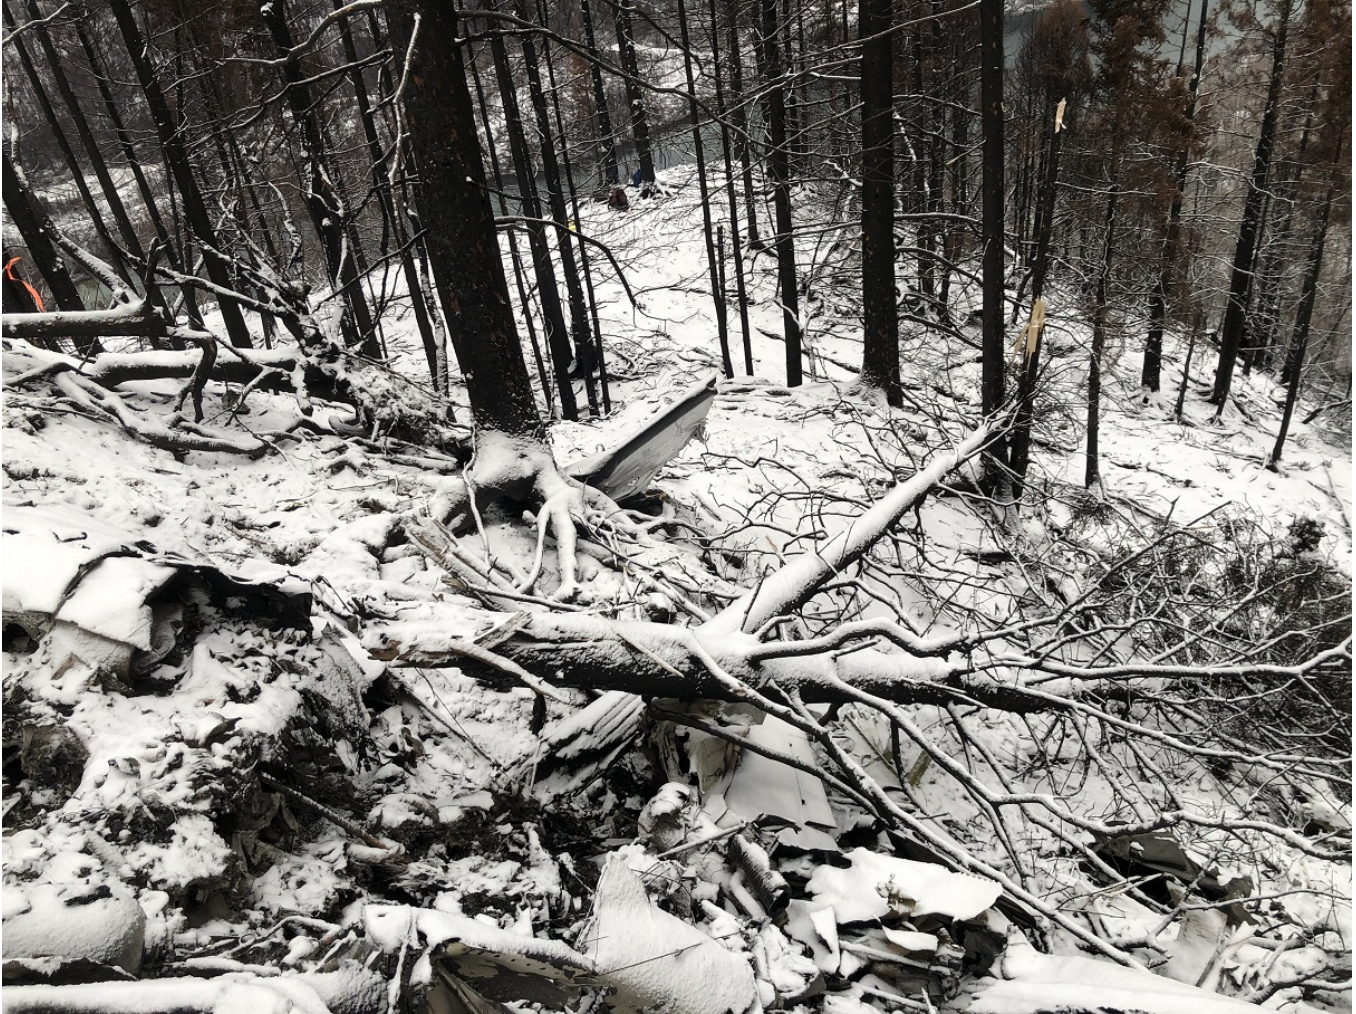
Figure 3. Accident site

On December 1, 2019, the Alaska State Troopers coordinated a mountain recovery mission with Alaska Mountain Rescue Group. The wreckage was observed on the mountain at an elevation of about 1,425 ft msl in an area of steep, heavily tree-covered terrain near the southeast end of Jean Lake in the Kenai National Wildlife Refuge. The airplane was highly fragmented and burned, however all major airplane components were accounted for. Multiple large trees around the wreckage were fractured and indicated an easterly heading prior to the initial impact. Refer to figure 3.
