## MIRAGE FATAL ACCIDENT ON BUTTERWORTH RUNWAY 06 July 1976

*By Jim Hall*

### Mirage Tragedy

By Paul Cross.  
Deputy Director Safety Communications  
(DDAAFS)

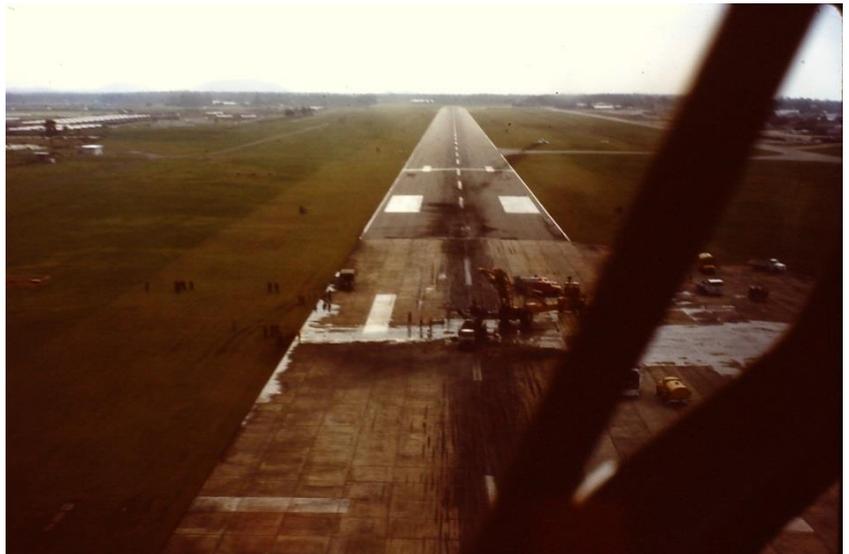
At the time I was a Herc Flight Engineer on C130A's at 36 Squadron and we were on a regular Butterworth supply run which on the day meant Darwin-Tengah (RSAF Fighter Base in Singapore) - Butterworth. We were taxiing at Tengah for Butterworth when the runway at Butterworth was declared 'black' i.e. closed, so we taxied back and shut down. Sometime later we were given clearance to proceed to Butterworth and land over the wreckage which was basically in the centre of the ideal landing area of the runway (RWY 18). The remaining available runway was ample for a C130. Here is what I know and I have attached a couple of pictures (hitherto unpublished) I took as we landed over the top of the wreckage.

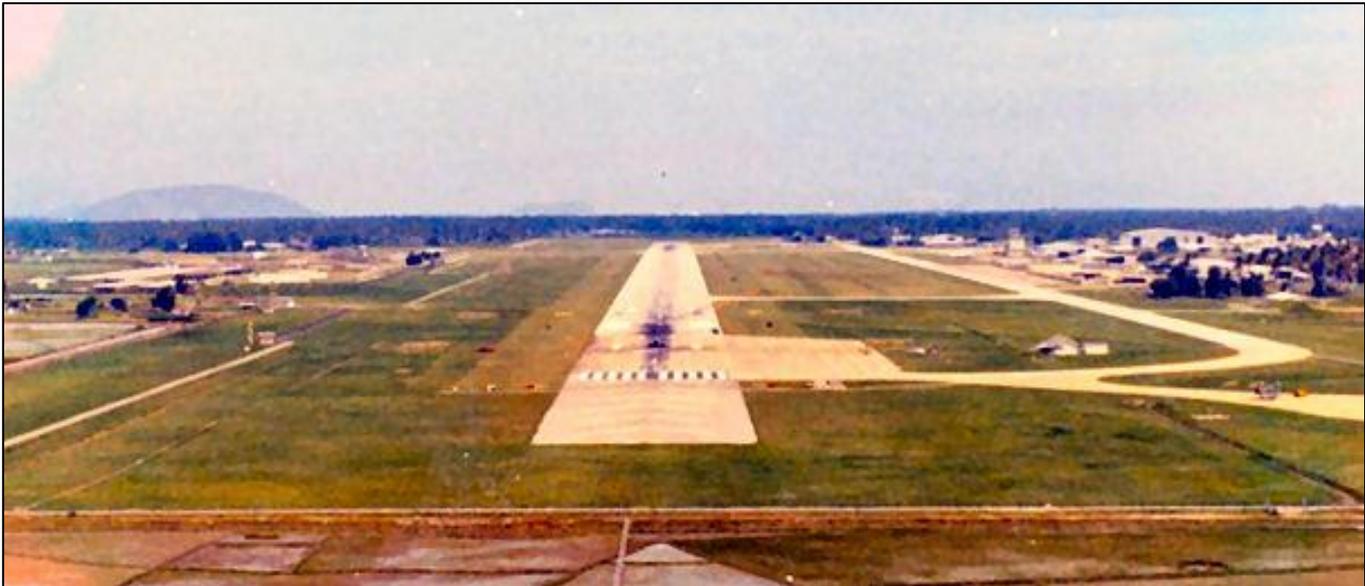
Investigation image one mile GCA Finals with Mirage lined up

“During a simulation it was apparent that the target aircraft became invisible when displaced one to two degrees from the central vision. Thus, unless A3-26 had been fixated centrally, the probability of target detection and recognition would have been very small. “Although many pilots are unaware of reflections in aircraft windscreens, this does not alter the fact that they impose an additional load on the visual system and reduce contrast ratios of targets seen through these reflections, thereby reducing the probability of successfully detecting a low-contrast visual stimulus.”
