"Houston, we've had a problem":

The story of NASA's most successful failure.

ALUMNI magazine

Wind Tunnels in the AAFC

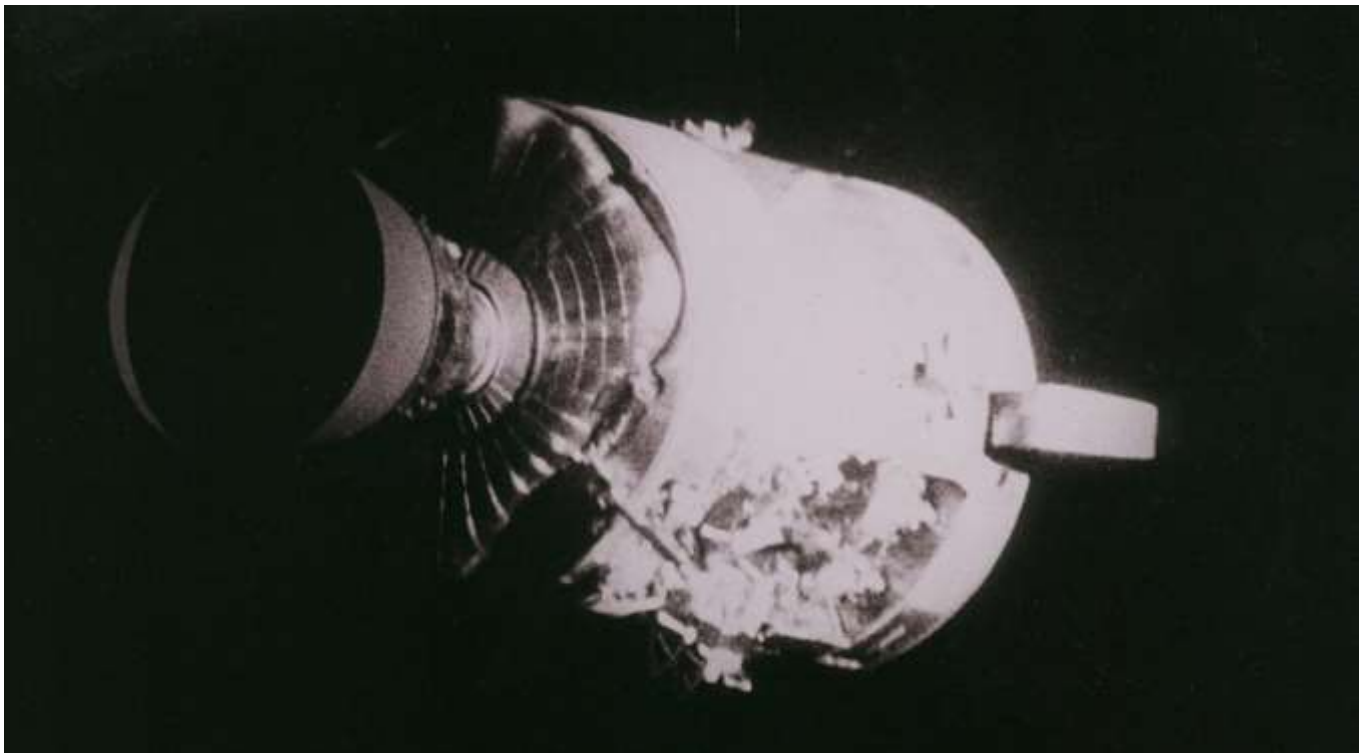
The Apollo 13 service module showing explosion damage.

Though an entire panel fore and aft on the service module was blasted away and there was extensive damage, the first clue the astronauts had that something was wrong was a loud bang. At the same time, telemetry with Earth went out for 1.8 seconds, the power readings on the instrument panel started fluctuating and the spacecraft was jolting as the automatic pilot kept firing the attitude control thrusters to compensate against some unknown force.

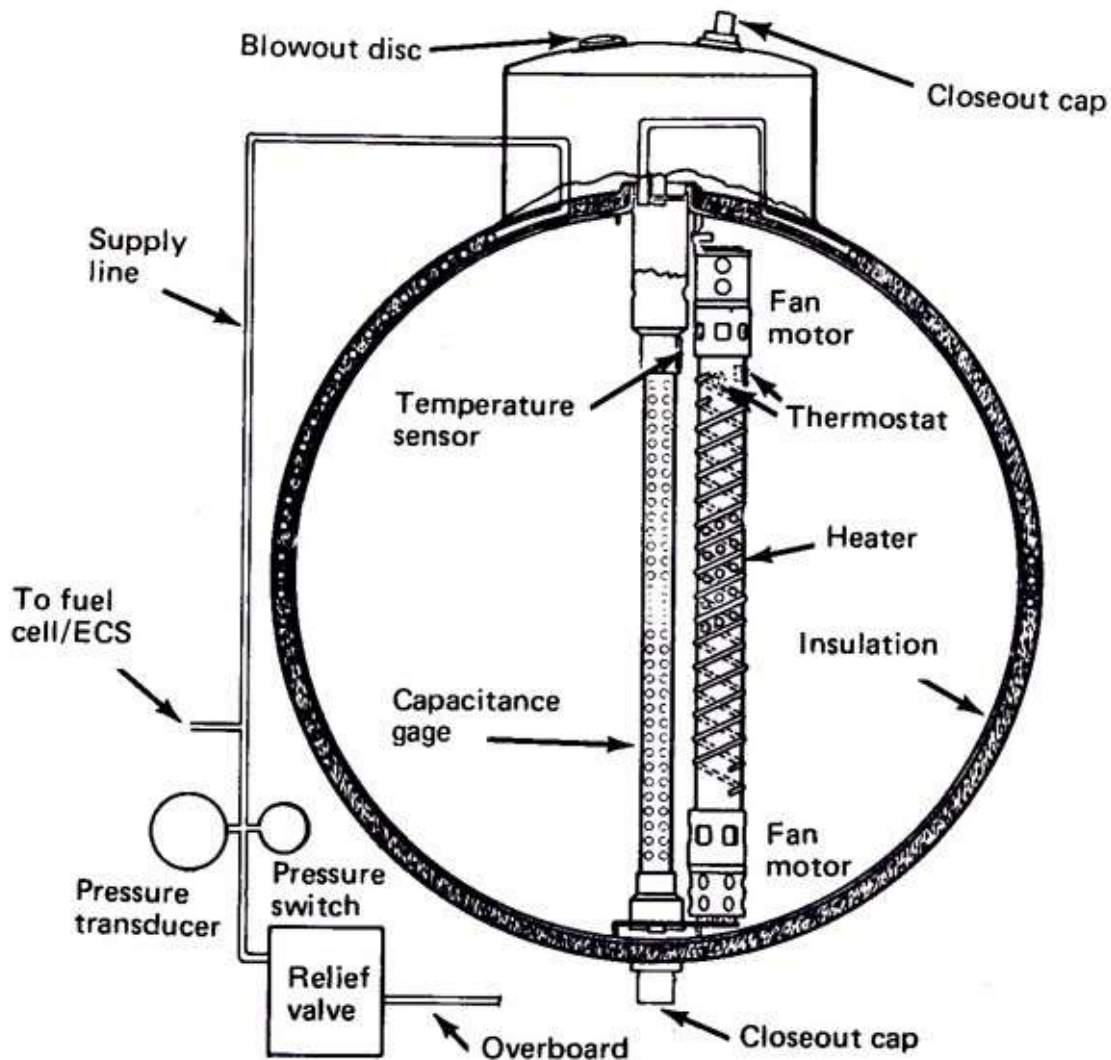
Diagram of the Apollo 13 oxygen tank design

Behind the conical command module that acted as a home for the Apollo astronauts is the service module. This cylindrical assembly with a bell-like cone at one end contained the main engine and supplied Odyssey with oxygen, water, electricity, and long-range communications with Earth. Inside the service module was a bay holding a number of systems, including two liquid oxygen tanks that were the primary source of oxygen for the command module. Also in the bay were a tank of liquid hydrogen and three fuel cells. The hydrogen and oxygen feeding into the fuel cells provided Odyssey with power and water. There was a history to one of these units. The No. 2 oxygen tank had been previously installed in the service module of Apollo 10 but was then taken out for modification, during which it was damaged and then sent back to the factory for repairs. It was then installed in the Apollo 13 service module.

Like all NASA flight gear, the No. 2 tank was tested and retested even after installation. On March 16, 1970, the tank suddenly developed a fault. It wouldn't drain properly. It was finally decided to run the tank's electrical heater to boil the oxygen. This didn't resolve the problem entirely, but because the oxygen tanks didn't need to drain in space and due to time constraints, No. 2 was cleared for flight.

However, the heaters had been upgraded so that they could operate at 68 volts instead of the previous 28 volts, but the thermostatic switches that controlled the heaters weren't changed. As

a result, during the final test, the switches welded shut and the wiring was frayed. Another problem was the use of aluminium components and Teflon insulation, both of which burn in pure oxygen.

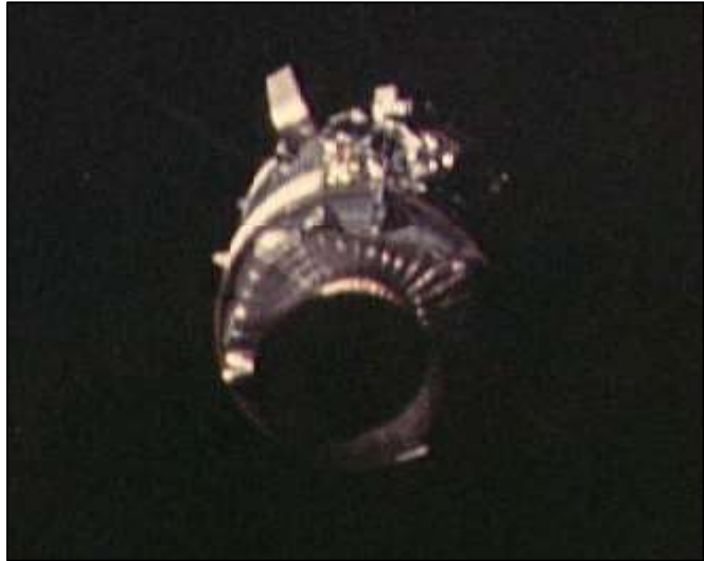
The Apollo 13 service module after separation

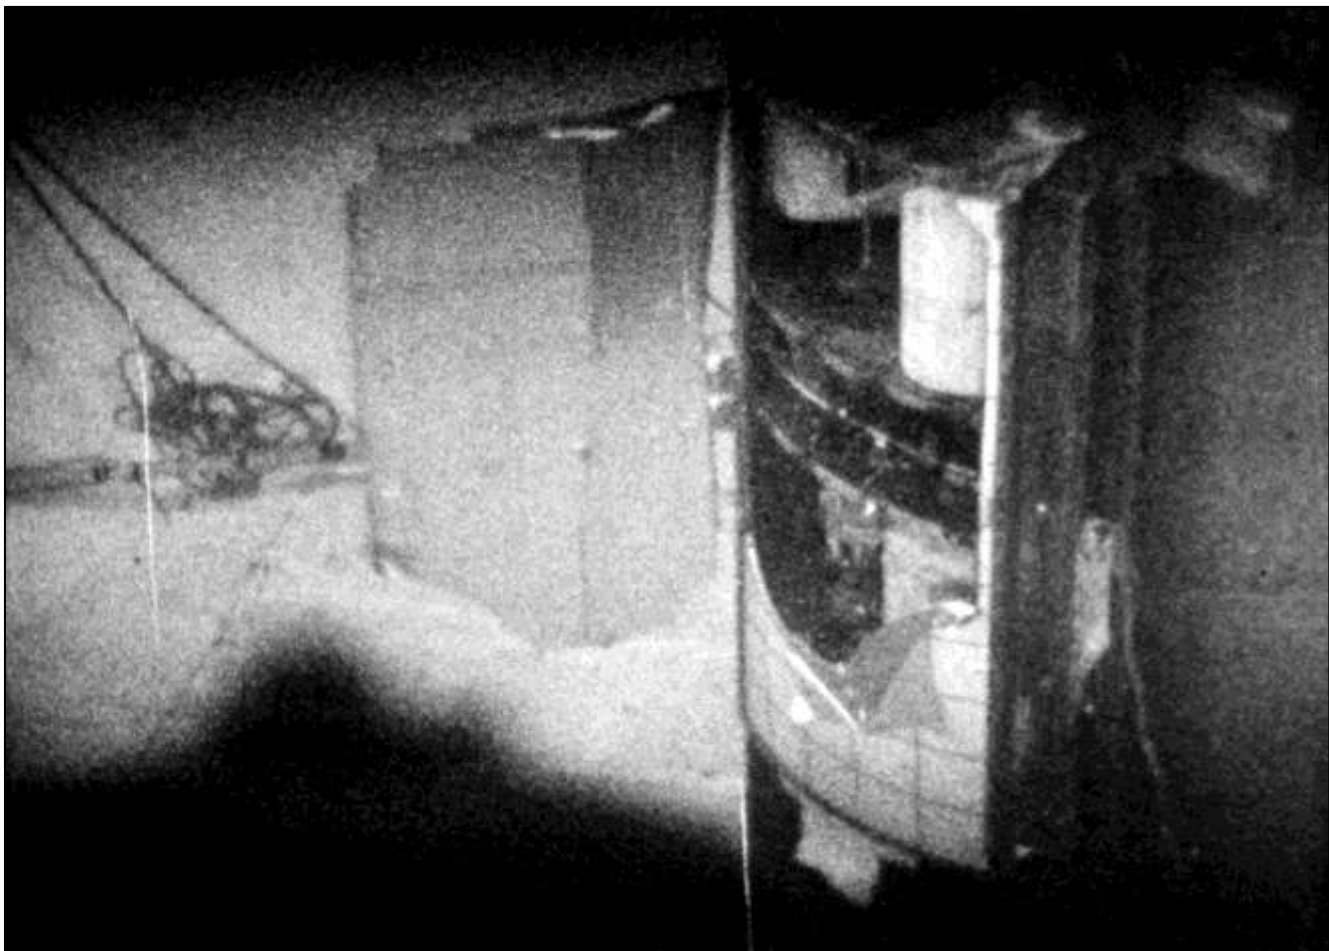
Post-flight test shows how the oxygen tank explosion blew off the service module's bay panel

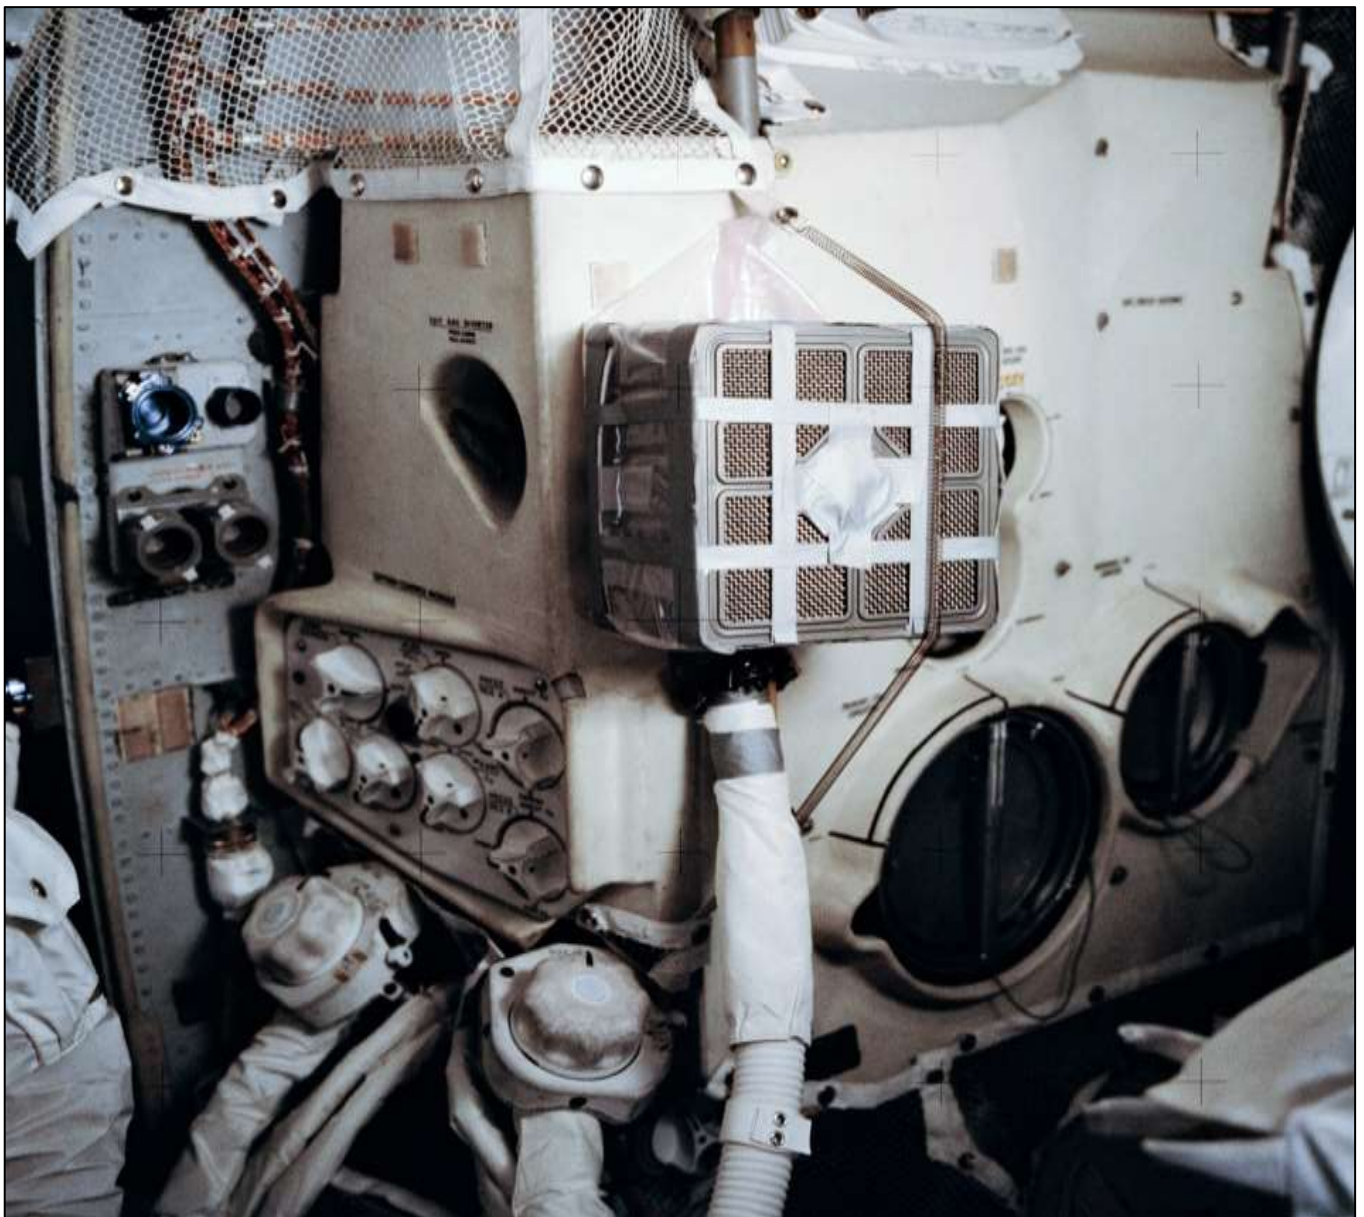
The "mailbox" adapter installed

In an ideal world, this would have been an easy fix. The command module also had scrubber canisters, more than enough for the trip home. Why not just move them over and plug them in? The crew couldn't because the canisters aboard Aquarius were round and the ones from Odyssey were square. Like a bad joke, the round holes of Aquarius' life support system wouldn't accept Odyssey's square pegs. Like those school exercises where students are given a bag of items and are told to build a crane or a hovercraft, NASA engineers had to as quickly as possible figure out how to build an adapter using materials known to be on the spacecraft, write up clear and detailed instructions on how to assemble it, and relay this to the astronauts.

According to Apollo astronaut Ken Mattingly, the solution was from a simulator exercise for training the Apollo 8 mission crew, where a similar emergency was solved by blowing air through a canister using the spacecraft's vacuum cleaner hose.

They soon came up with a contraption called the "mailbox," which was made from plastic, covers from procedure manuals, vent hoses, and other bits and pieces, all held together with duct tape. Just reading the procedures over the radio took an hour.

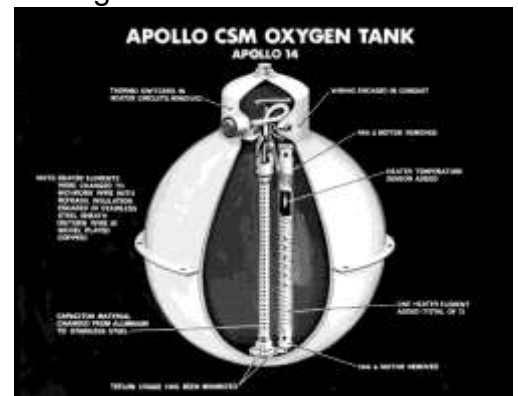
The improved oxygen tank used on Apollo 14 and later missions

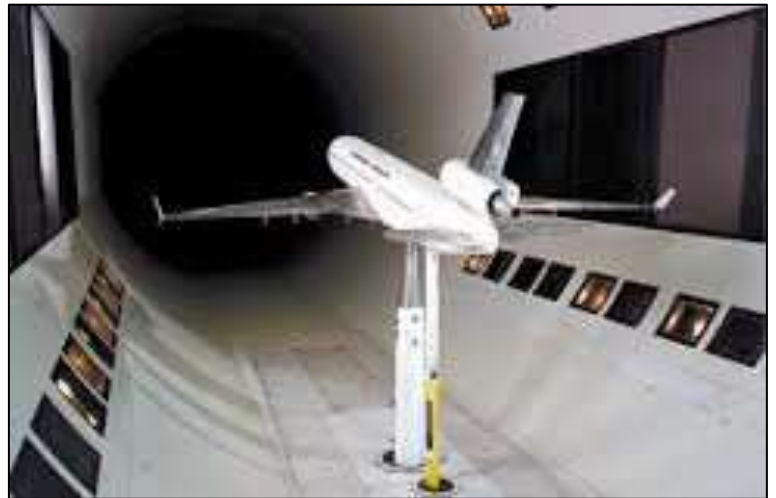
The 315SQN AAFC Wind Tunnel set up with a smoke generator.

The Wind Tunnel is made up of a range of parts. Firstly, wind generation is critical to the tunnel's performance to deliver enough wind to complete the test undertaken. In this case, they used a three-speed desk-top fan to deliver three separate wind velocities. Whilst the fan delivered sufficient wind for their purposes, a Contraction Cone was used to increase the velocity of the air to deliver more credible results. A Contraction Cone reduces the intake dimensions between the fan and the test article (and thus the volume of the tunnel) to increase the mass flow of the air, providing an artificial increase in velocity in the test section. The next component is the Settling Chamber to straighten the turbulent air coming off the fan so that it delivers a more controlled result over the test article. They used cardboard wrapping paper inserts to do this. The next section is the Test Section, where all the action happens. Finally, if required, the exhaust may have a Diffuser to reduce the velocity and mass flow of air leaving the Wind Tunnel. Their tunnels were low velocity and thus did not require a Diffuser.

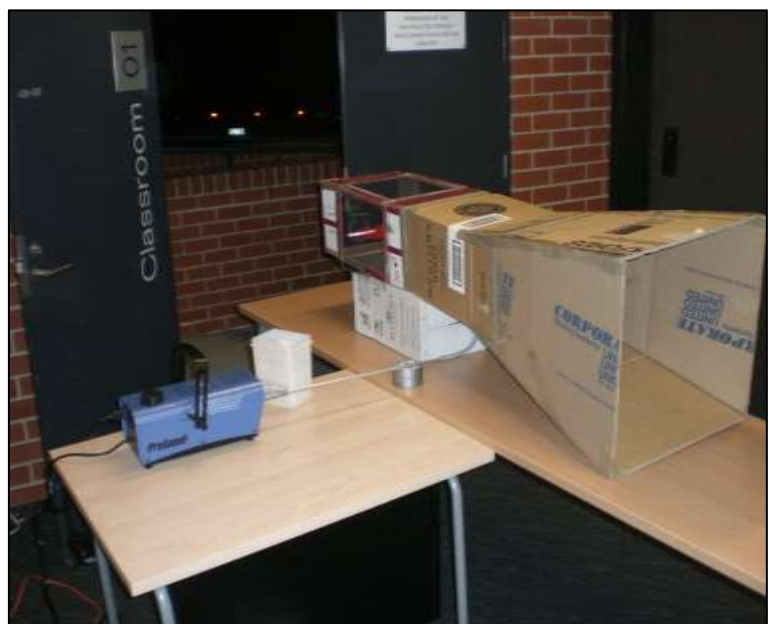
The same tunnel showing smoke in the Test Section going over the wing whilst the Angle of Attack is adjusted.

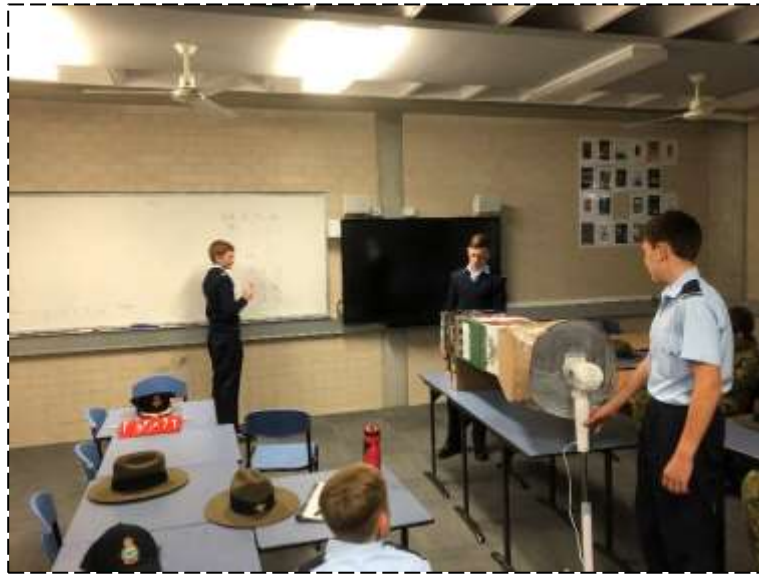
The various Angles of Attack are tested at the three wind velocities and transcribed into a Matrix on the Whiteboard.

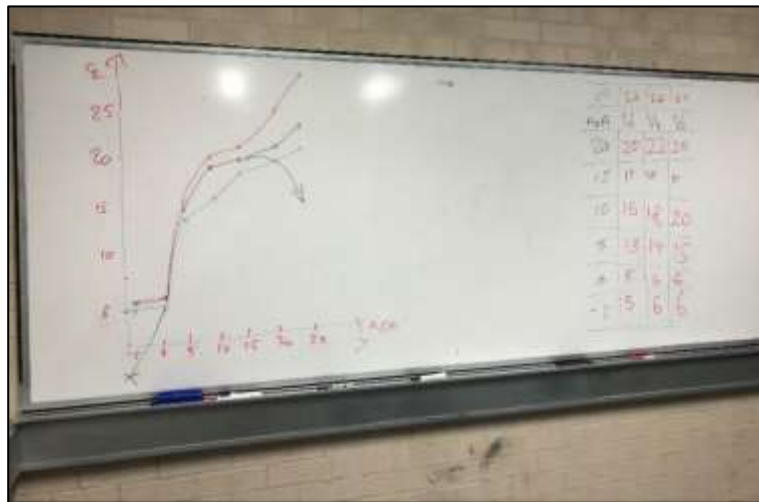
Test Matrix and Graph

The test figures are then plotted on to a two-axis graph covering Angle of Attack on the bottom and Coefficient of Lift on the top to identify the result. The result demonstrated some flaws in the test design, where the test article tended to exhibit speed brake properties at high angles of attack, causing the result to be skewed. However, the result could be interpreted effectively as the Angle of Attack exceeded 15 degrees, where the numbers demonstrate a change in Coefficient of Lift output.

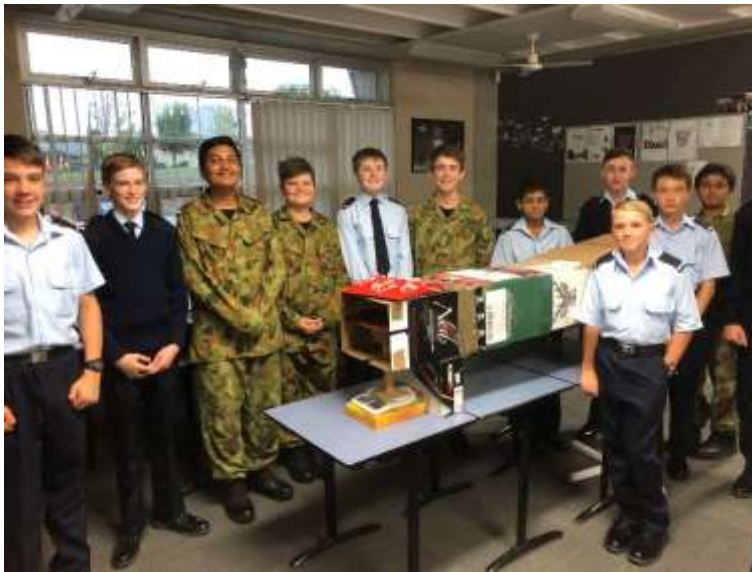
No 327SQN AAFC cadets with their Wind Tunnel.

On the top of the tunnel can be seen the Tufted Wing, which was manually rotated to vary the Angle of Attack whilst under test, demonstrating Boundary Layer Turbulence and Separation 'walking up' the wing from the trailing edge as the Angle of Attack is increased.
